DEVELOPMENT OF A PROCEDURE
TO NONDESTRUCTIVELY EVALUATE
THE FUSION QUALITY OF GEOMEMBRANE
SEAMS

RMD Report L-93

I.D. PEGGS
D. LITTLE

Hanson Materials Engineering
Edmonton

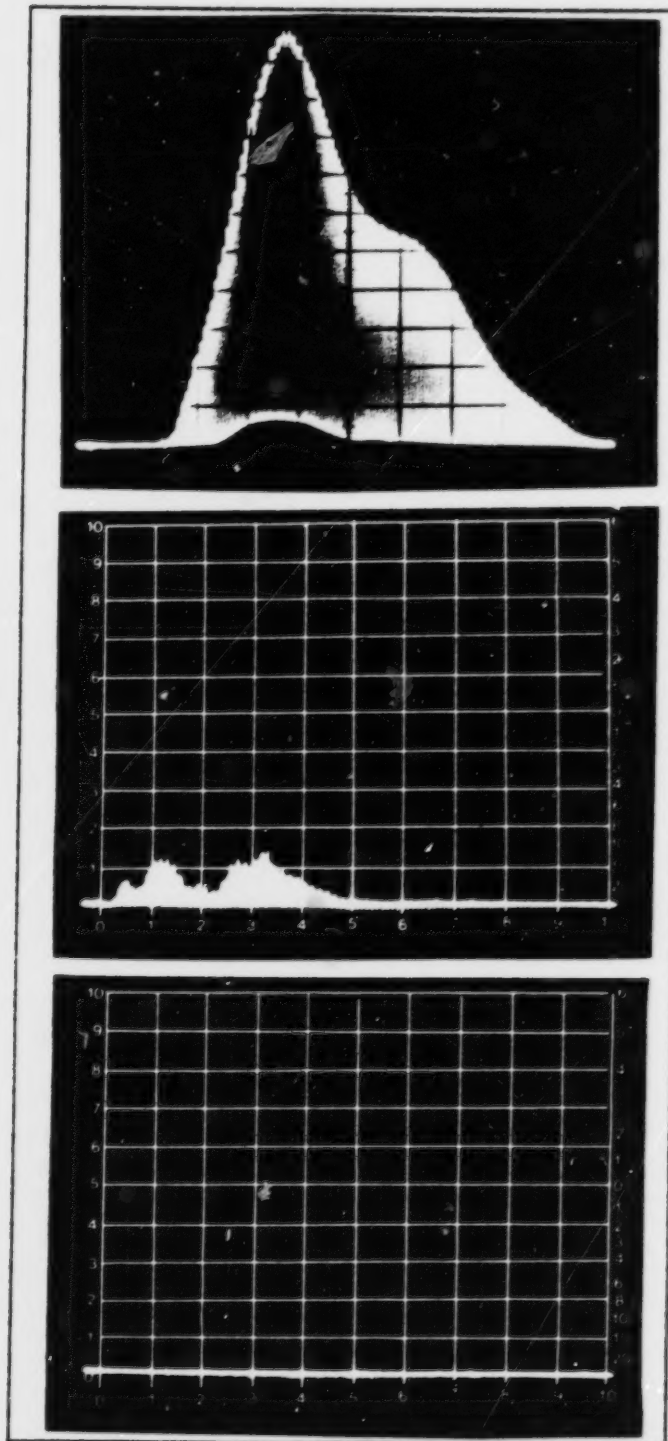
Figure 20. Signals modified by defects ranging from small voids to complete lack of fusion.

As defects are encountered the signal is modified, depending on the type and size of defect, until complete lack of fusion eliminates all sound transmission (Figure 20).

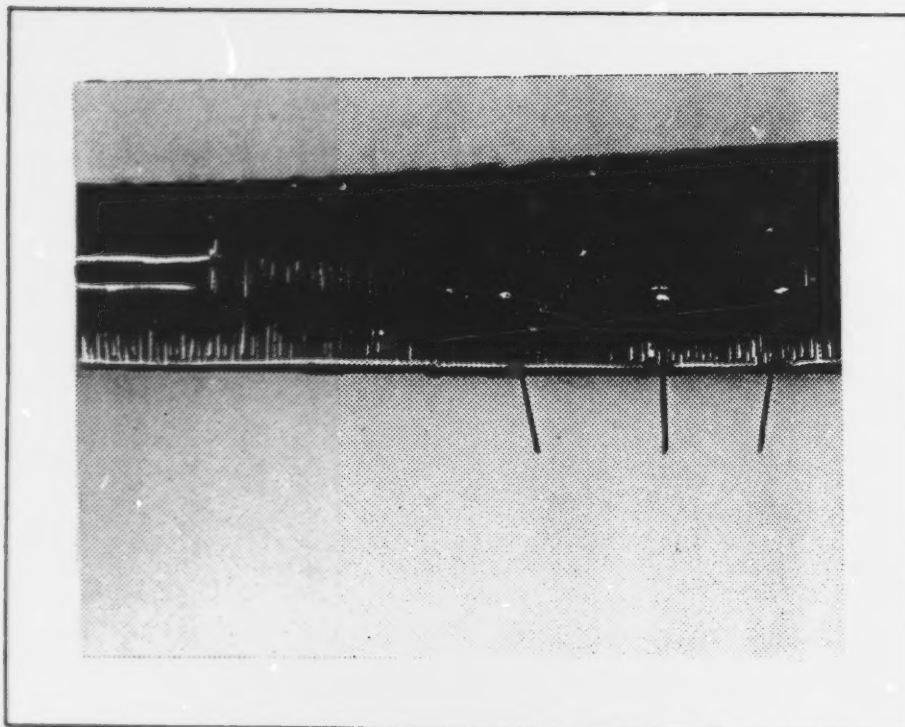
Ultrasonic indication over 44 mm of seam.

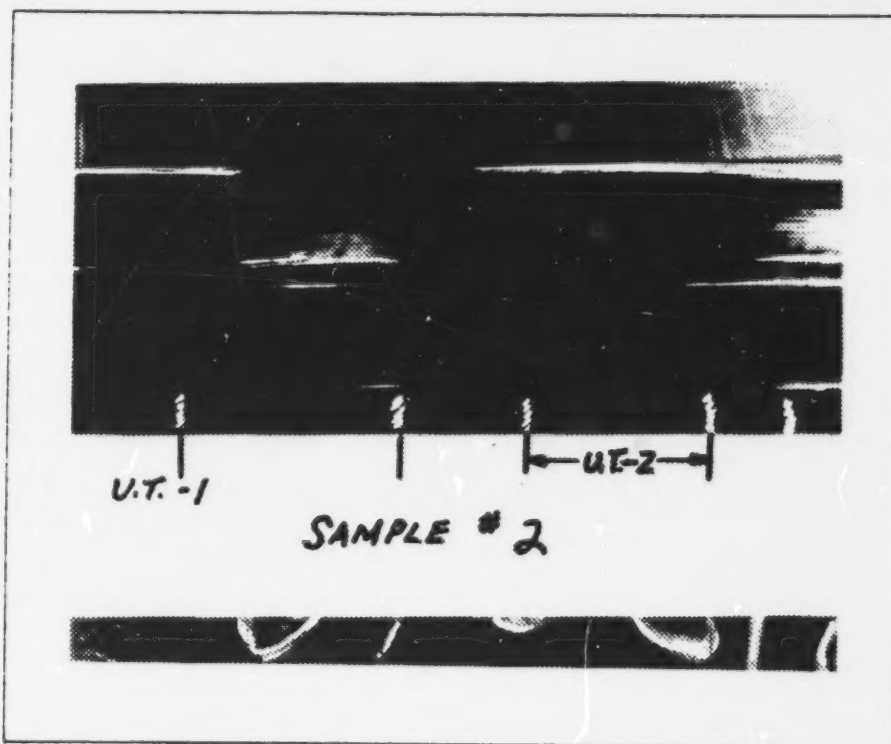
A microtome revealed many smaller particles (indicated with arrows) on the interface between the membrane and the extruded deposit.

Despite these observations, the peel specimen did not separate along the fusion line.

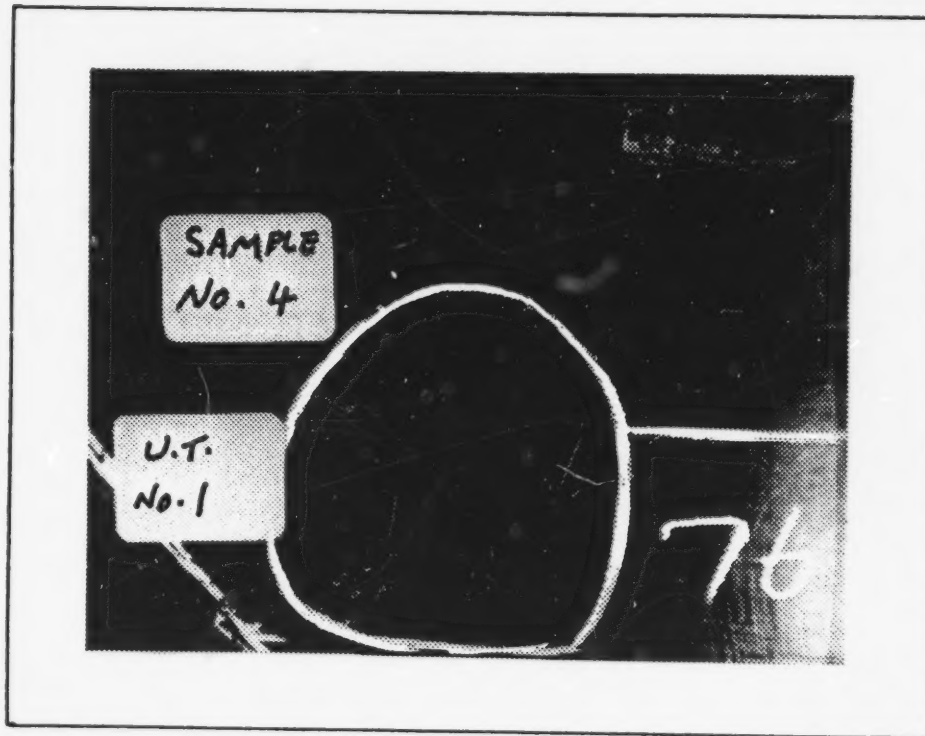
The microtome section again showed sand particles and intermittent poor fusion as evidenced by a distinct interface line.

The peel specimen showed 50% peel separation before failing through the membrane. Peel separation in excess of 25% is considered unacceptable.

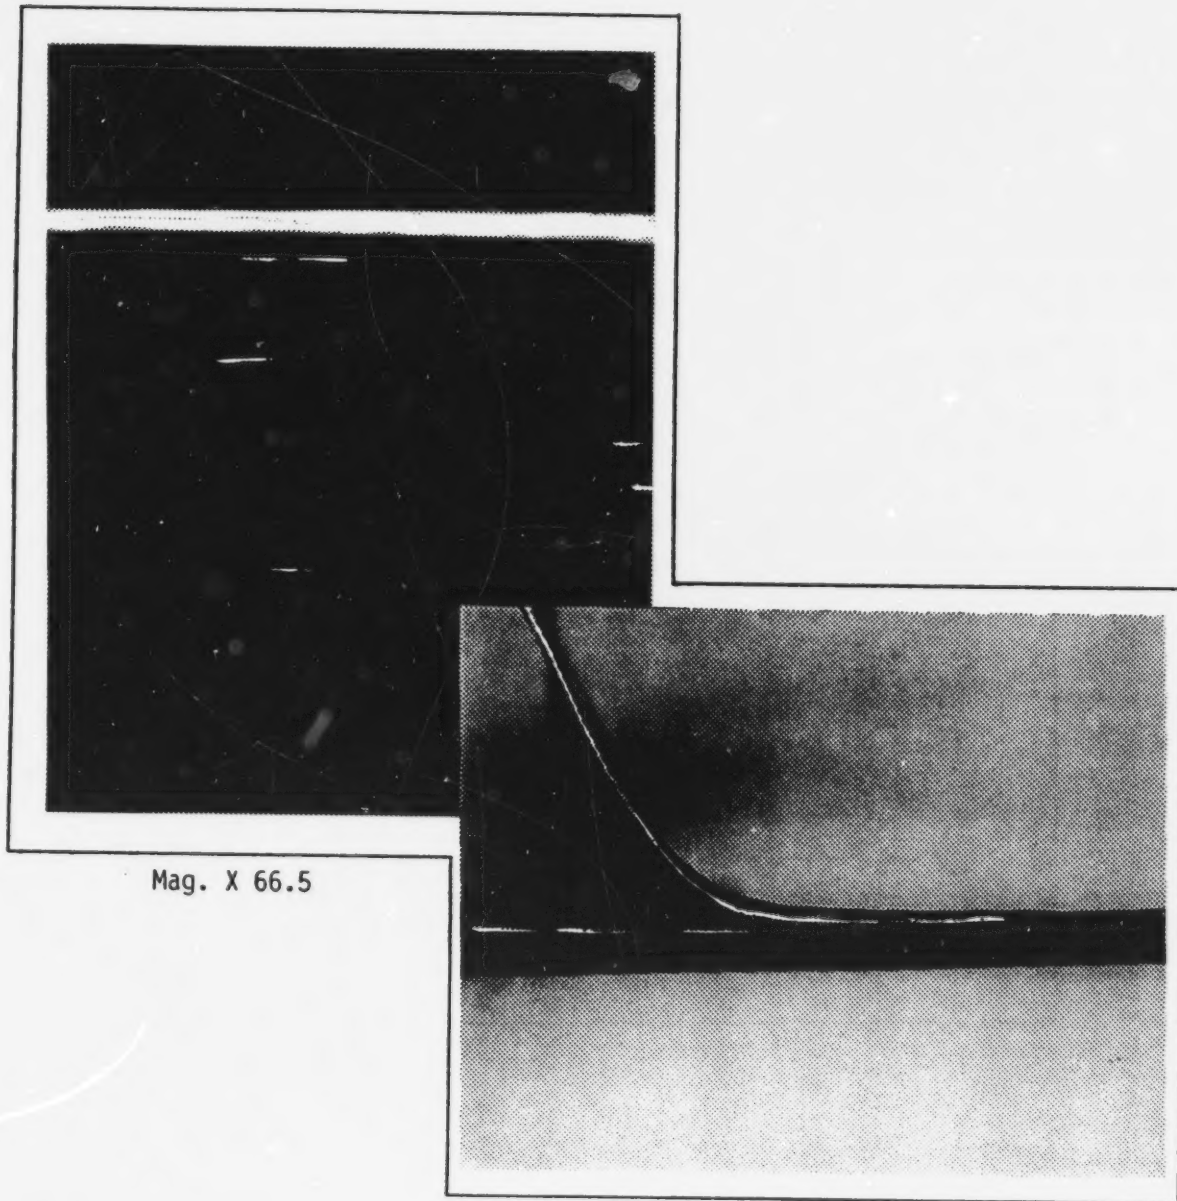
While calibrating the signal on the membrane, an indication was observed about 50 mm away from the seam. Continuous indications were observed all along the seam.

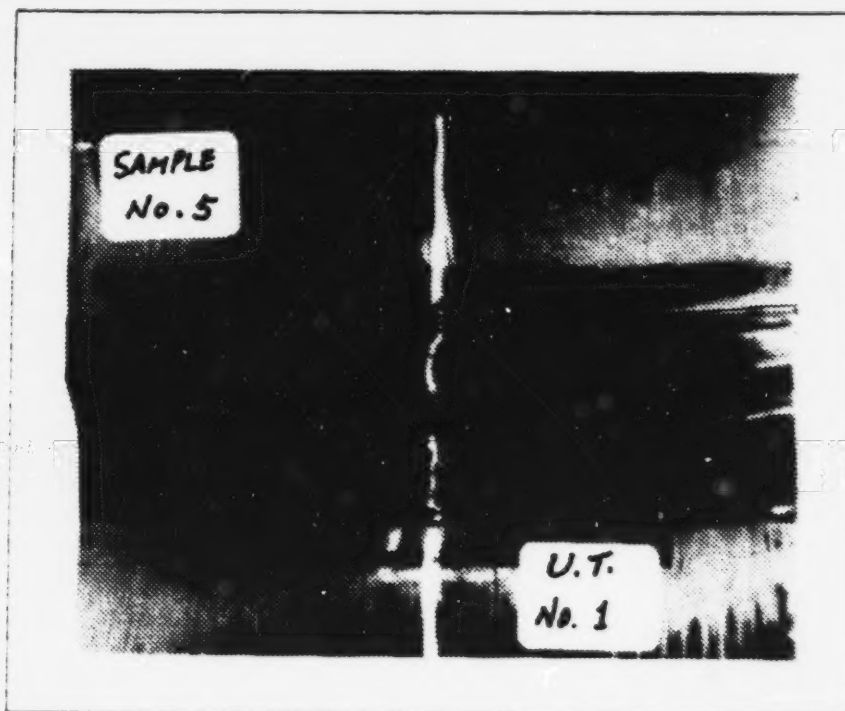
A microtome through the membrane revealed a laminar defect found to be a plane of low bond strength. The membrane could be delaminated along this defect.

Peel specimens peeled completely. Fusion quality was low and very variable.

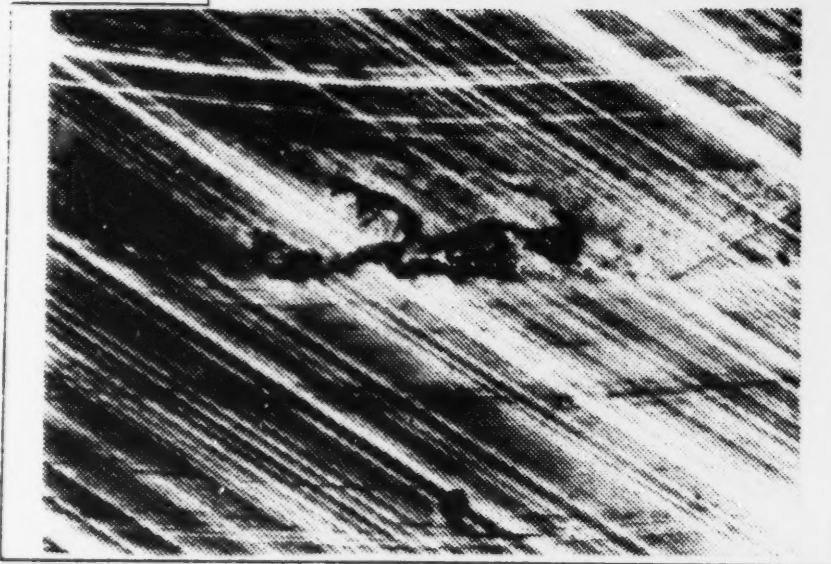
Two wide ultrasonic indications in a visually acceptable seam.

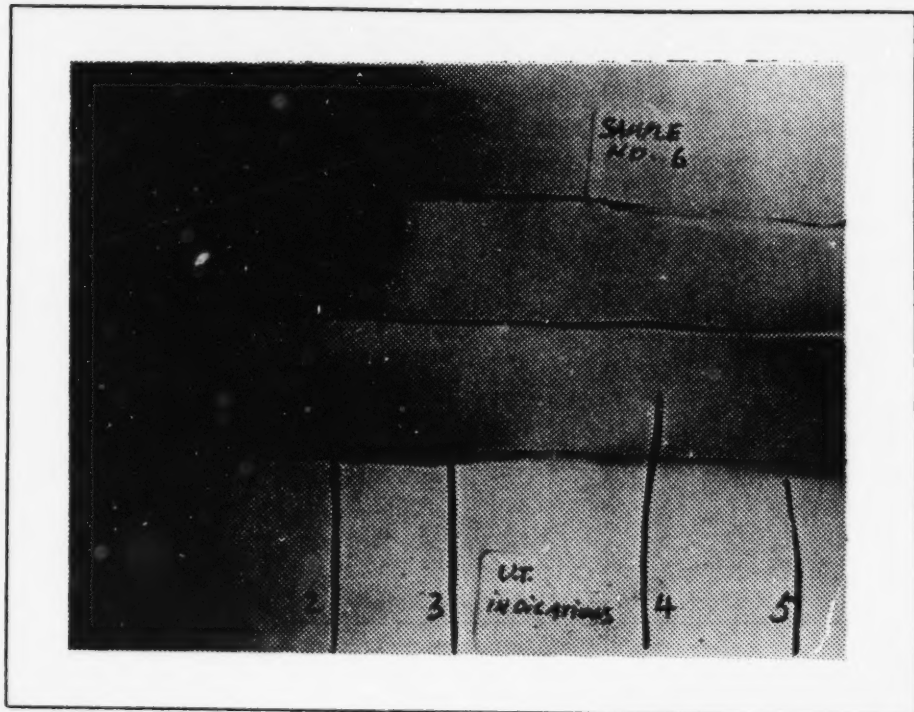
Microtome sections revealed dirt or sand particulates on the fusion interface and fibrous material within the extruded material. Lines indicated with arrows are microtome knife markings. The bars show the width of the extruded material in the bottom photograph.

The peel specimens separated completely. However, a peel specimen prepared from a region that gave no ultrasonic indication also peeled completely.

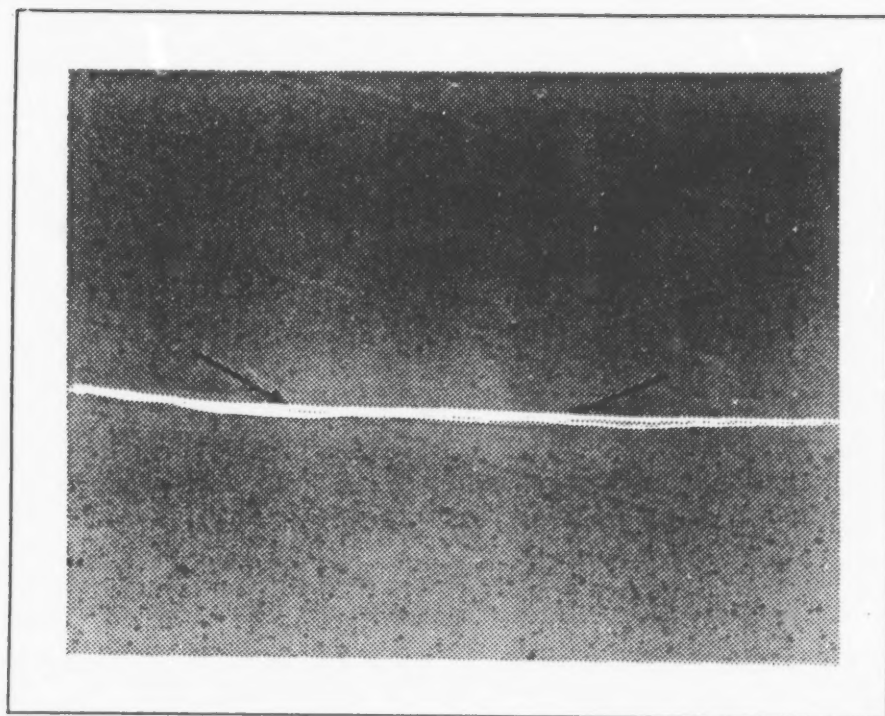
General, variable indications along the length of the seam. Some areas are obviously worse than others.

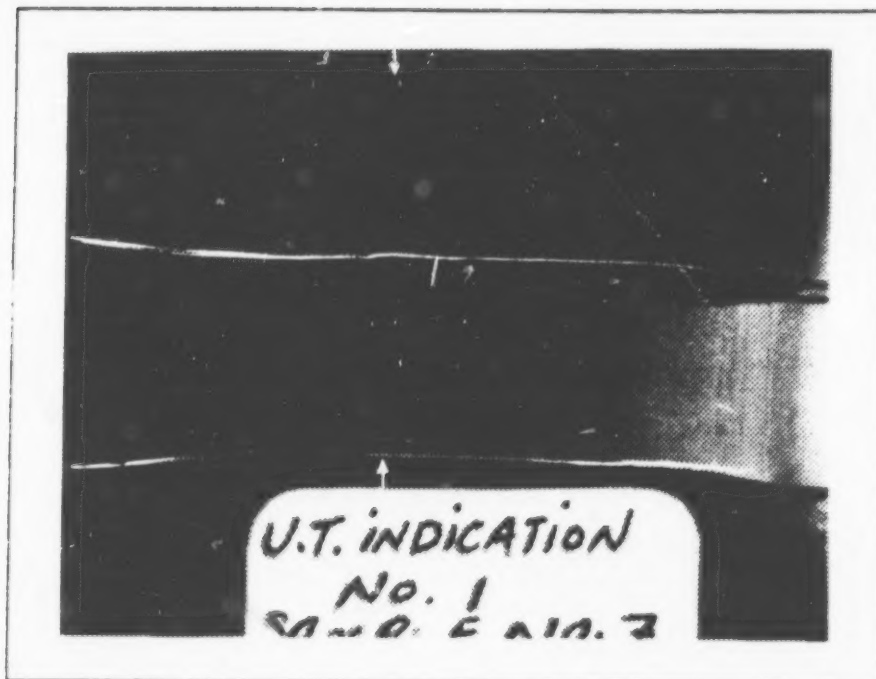
The microtome section shows a distinct interface (white band) where membrane surfaces have not adequately mixed in the solvent. The interface band contains a large void, which is indicated by arrows.

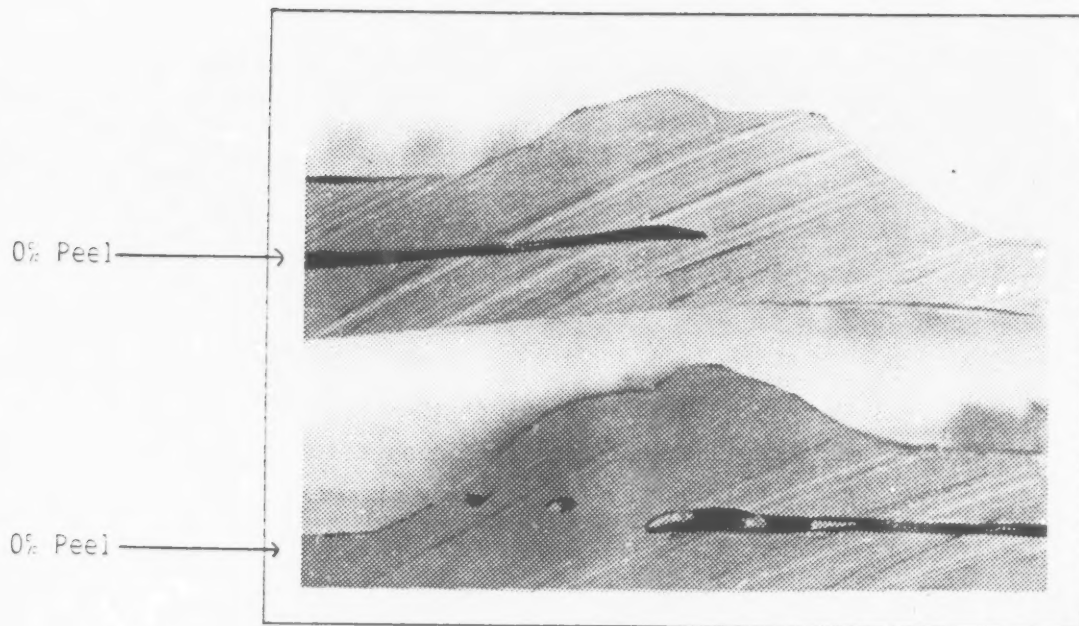
Mostly at 80% FSH with a few areas as low as 5% FSH. Porosity is again evident at the 5% regions, but peel specimens tested from both areas all showed satisfactory behaviour by failing away from the seams.

Seam cross-sections that produce 50% FSH signal (top) and 5% FSH signal (bottom).
